✓
AFML-TR-72-30

INSTALLATION OF A SELF-SEALING MATERIALS
SYSTEM IN A C-130 INTEGRAL FUEL TANK WING

Northrop Corporation
Aircraft Division

September 1972

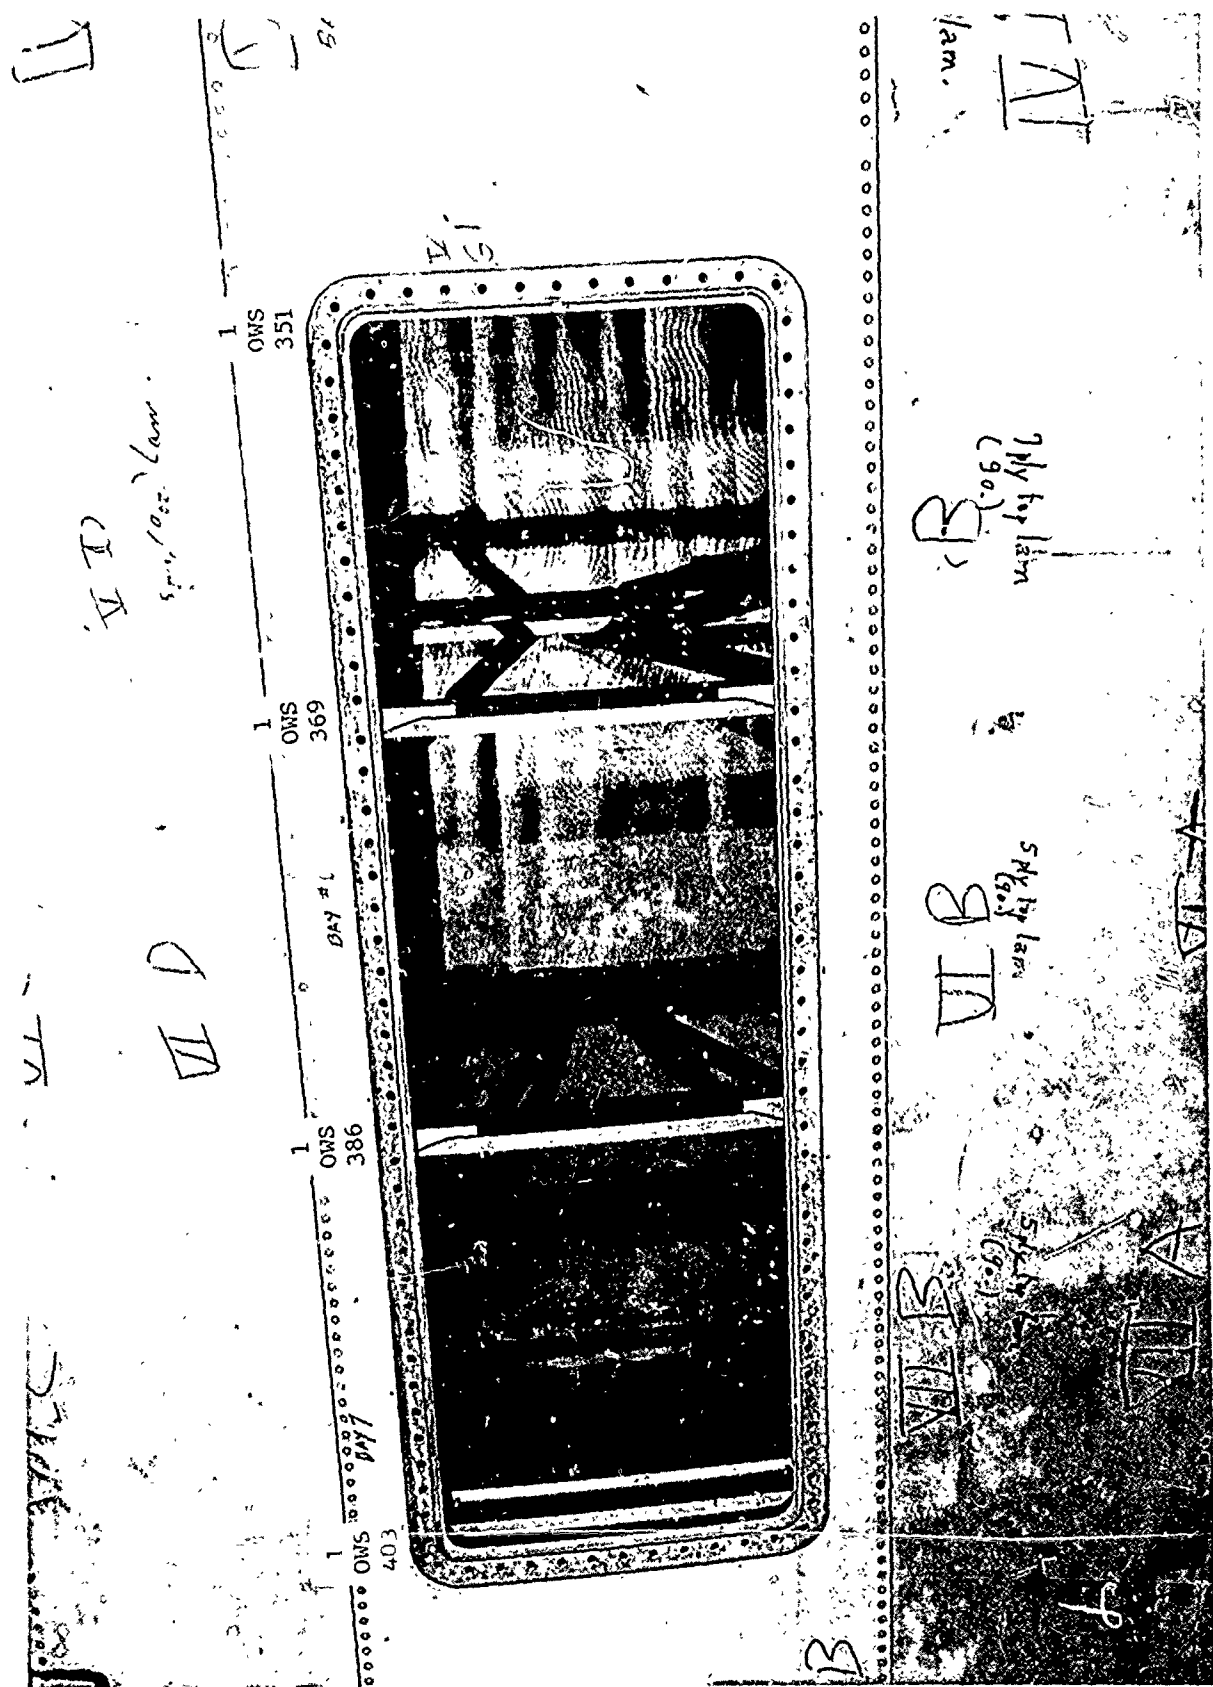
FIGURE 36. SELF-SEALING SYSTEM INSTALLED IN OWS 351 THROUGH OWS 403 OF THE FIRING TEST TANK

The precompressed foam and the plain flat flexible laminates were installed in the firing test tank in the same way as they were in the slosh and vibration test tank (see Sections C.4. and C.6. above). The installation was performed in only the six bays which are situated between OWS 300 through OWS 403. The bay between OWS 283 and OWS 300 had only the corrugated laminate (damage control system) installed in it. Figure 35 shows the corrugated laminate installed in OWS 283 to OWS 300, and the completed self-sealing system installed in OWS 300 through OWS 334. Figure 36 shows the complete self-sealing system installed in the bays situated between OWS 351 through OWS 403. The weight of the system installed was 1.85 pounds/foot². The thickness of the system exceeded the height of the structural ribs (7/8-inch) by 3/16 of an inch.

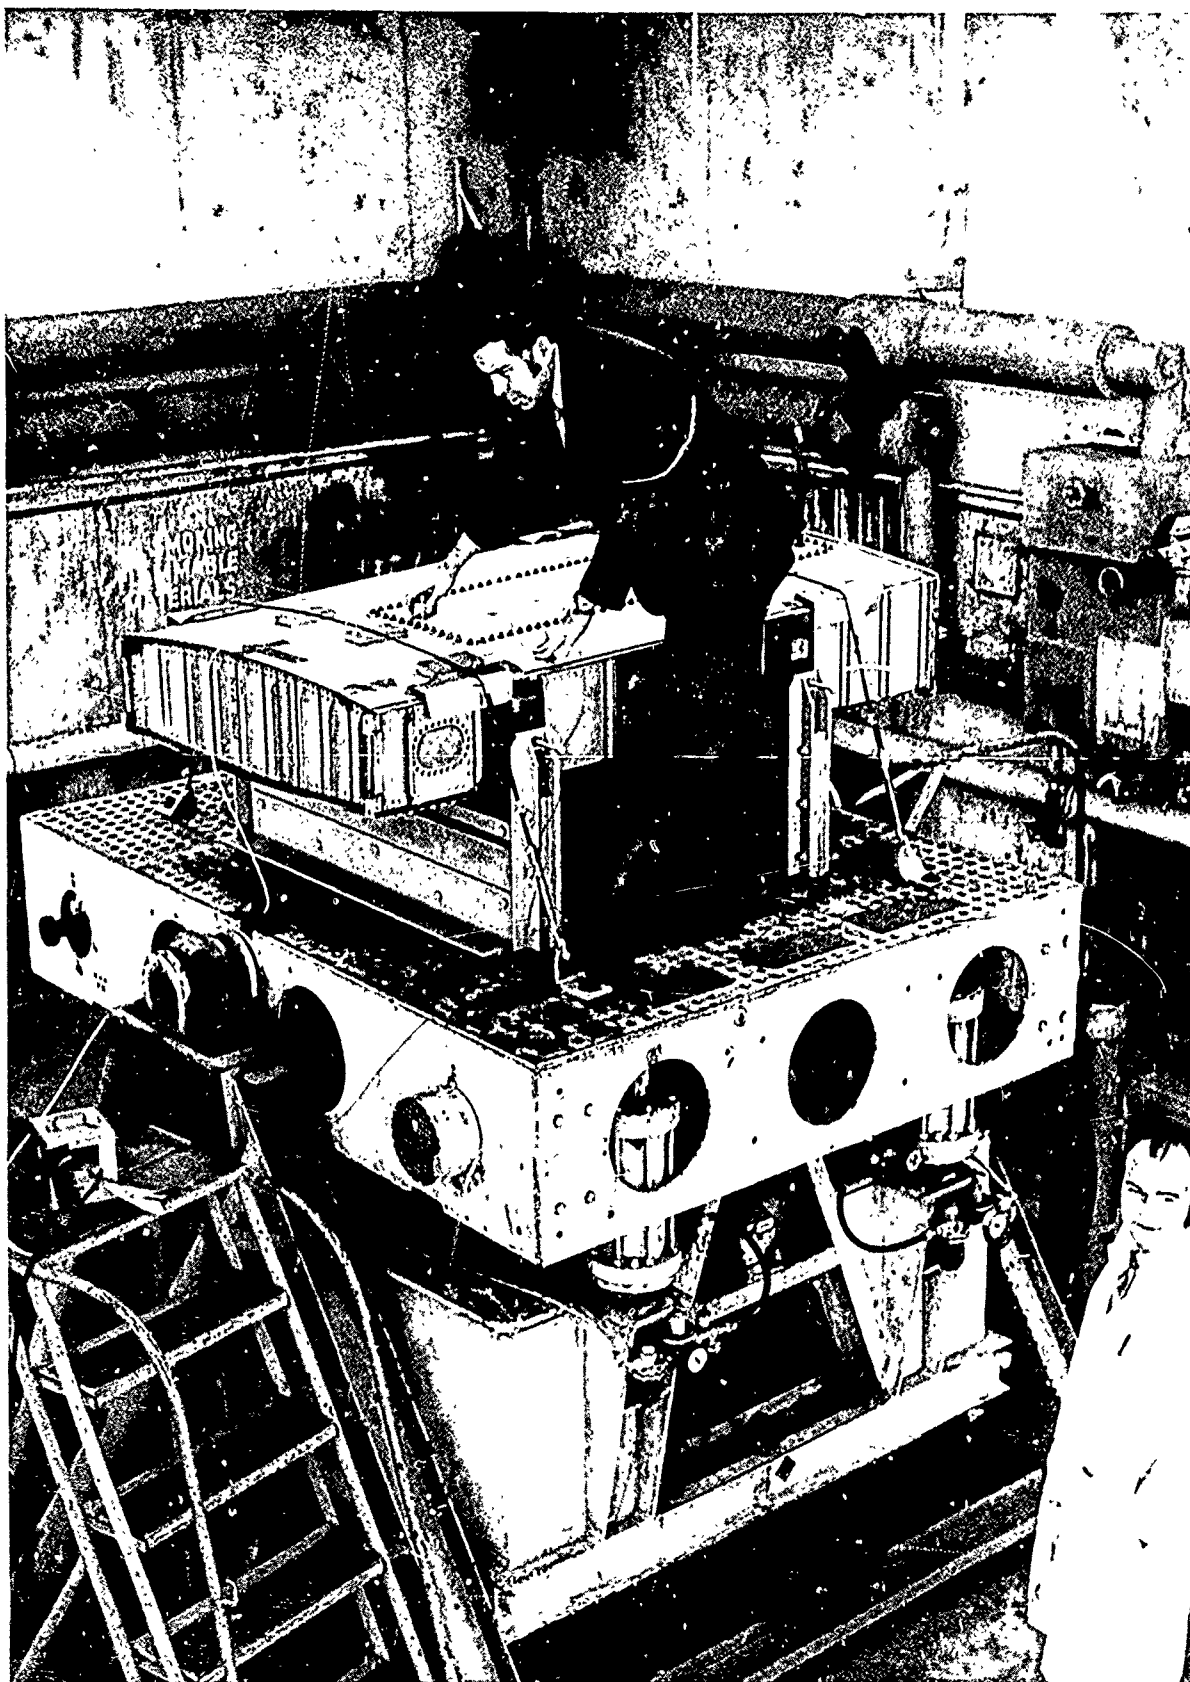
FIGURE 38. MEASUREMENT OF THE VIBRATION AMPLITUDE

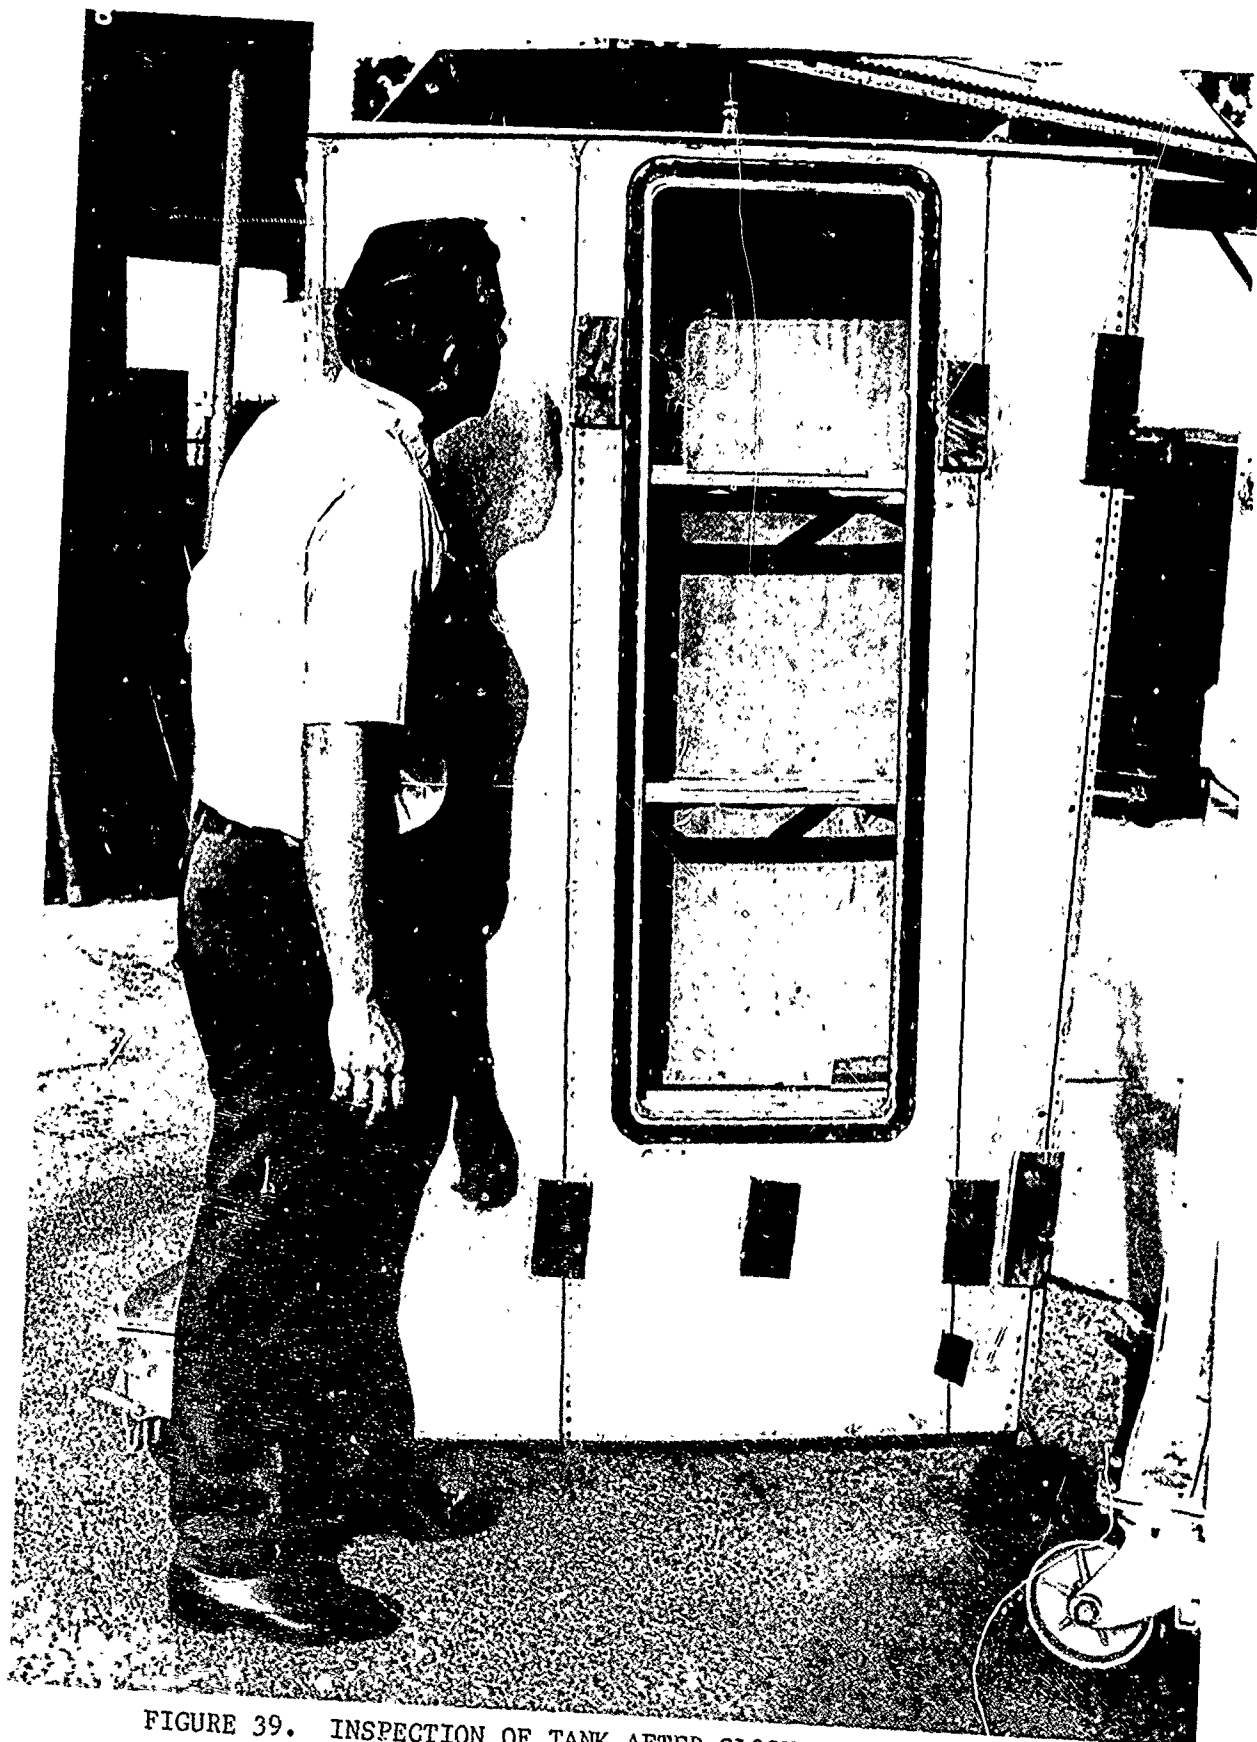
FIGURE 39. INSPECTION OF TANK AFTER SLOSH AND VIBRATION TESTS

1. No evidence of delamination or tearing of the damage protection and self-sealing systems (Figure 39).
2. Two failed vertical trusses in the Stations 509 and 526 rib structures.

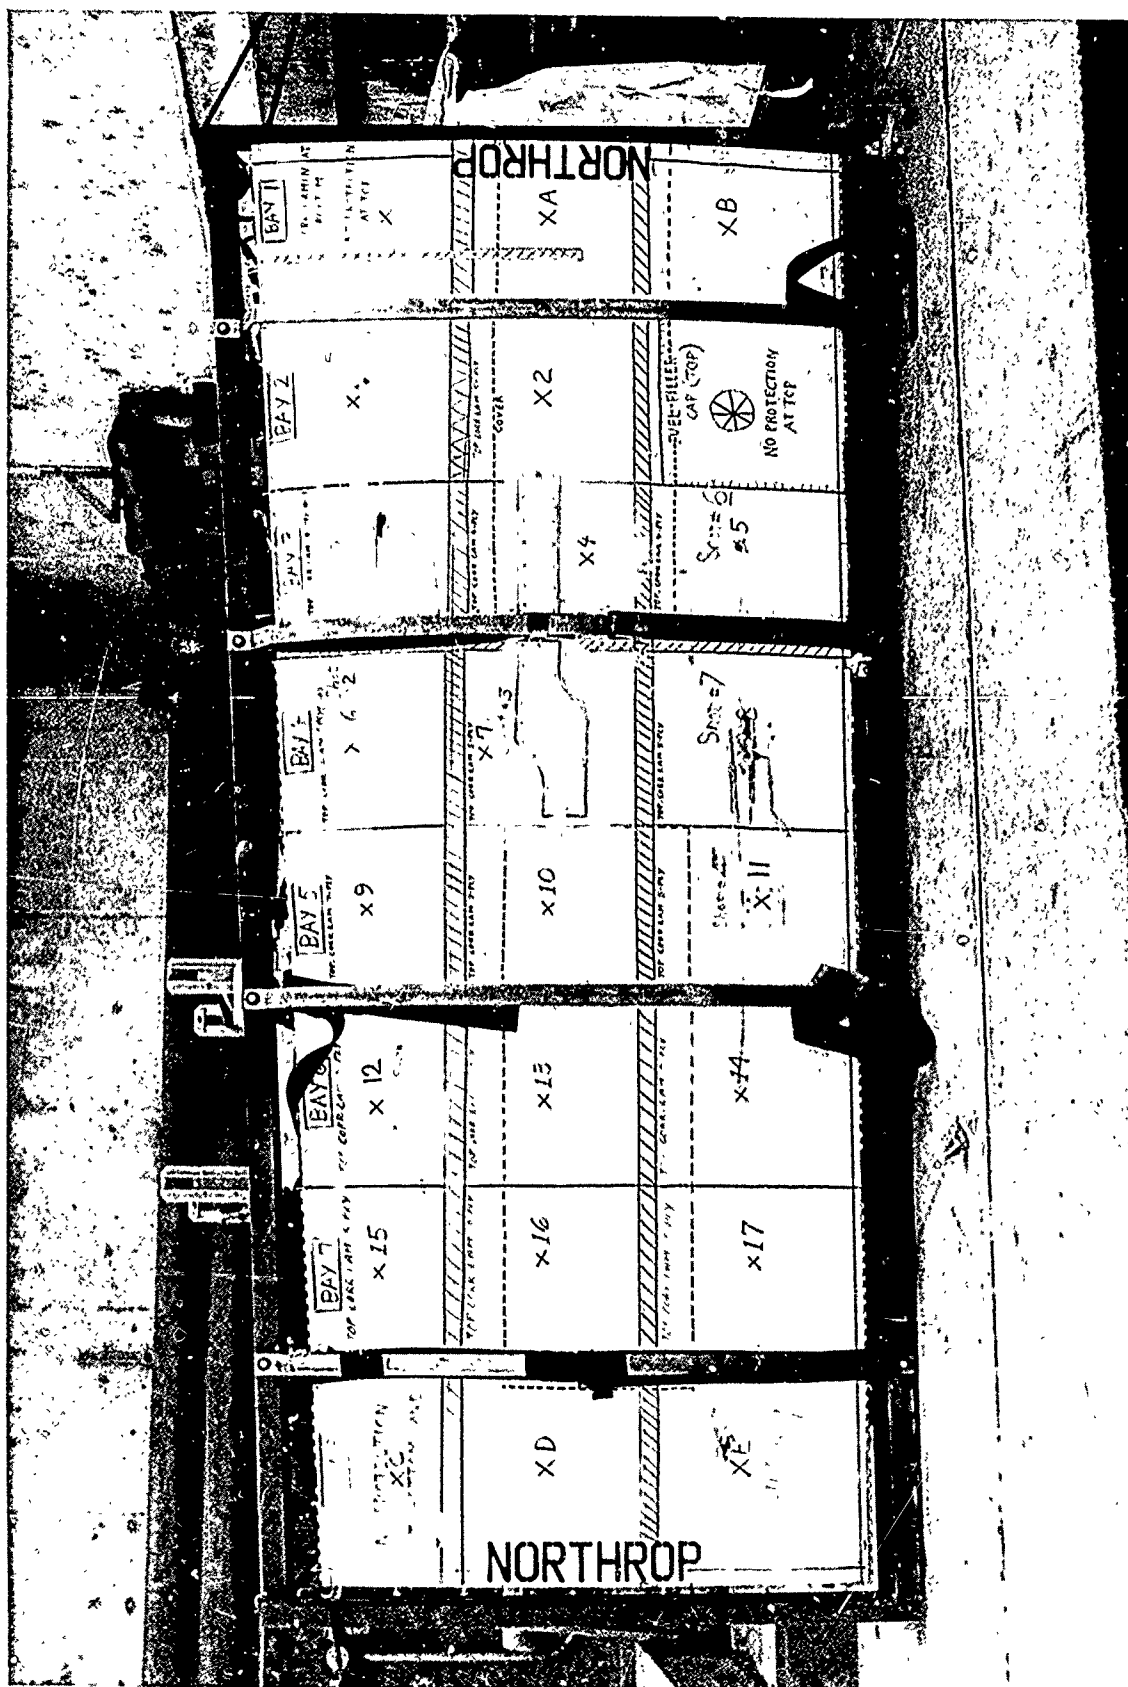
FIGURE 42. FIRING TEST TANK WITH MARKINGS

After the installation of the self-sealing system and the damage control system in the bottom and top sections of the firing test tank, the reticulated foam (orange type) was cut (Figure 40) to fit and installed inside the tank as shown in Figure 41. The two covers were then bolted on top of the tank. The outside bottom part of the tank was spray-painted white and marked as shown in Figure 42.

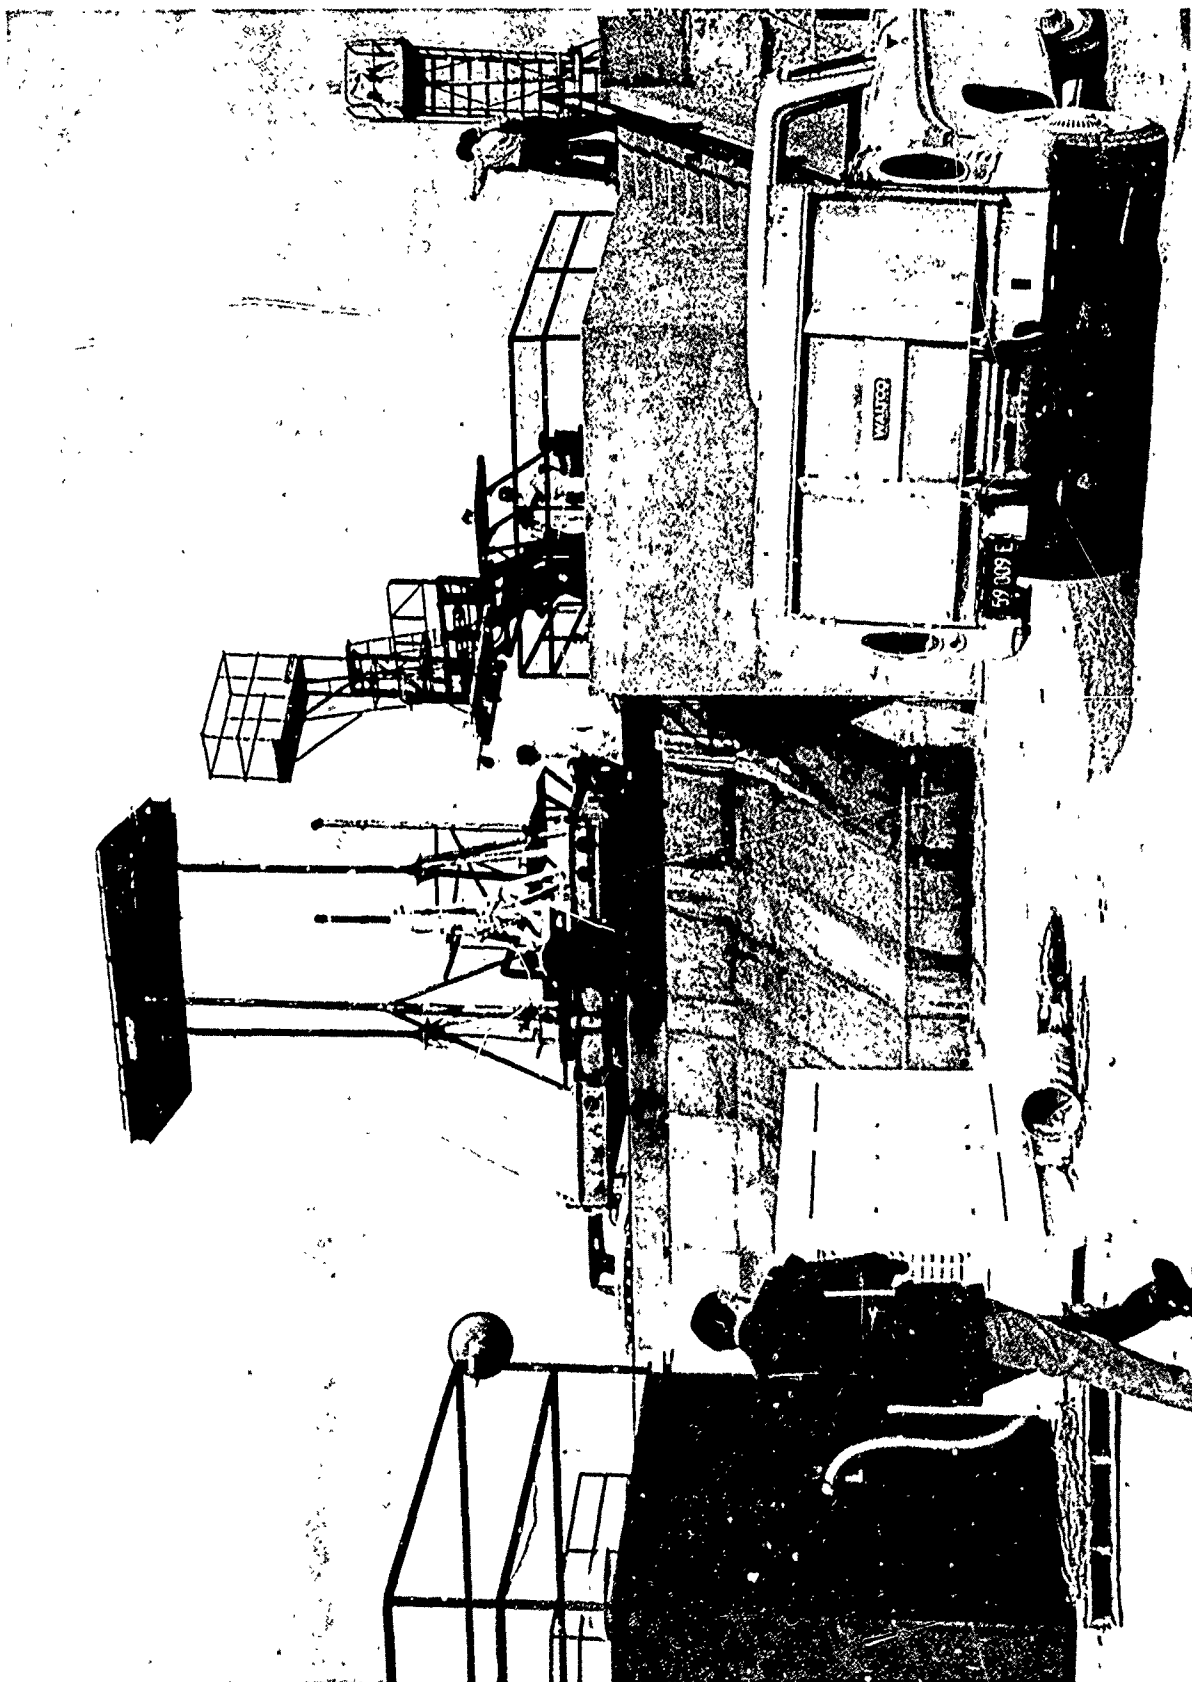
FIGURE 43. CHINA LAKE TEST FACILITY

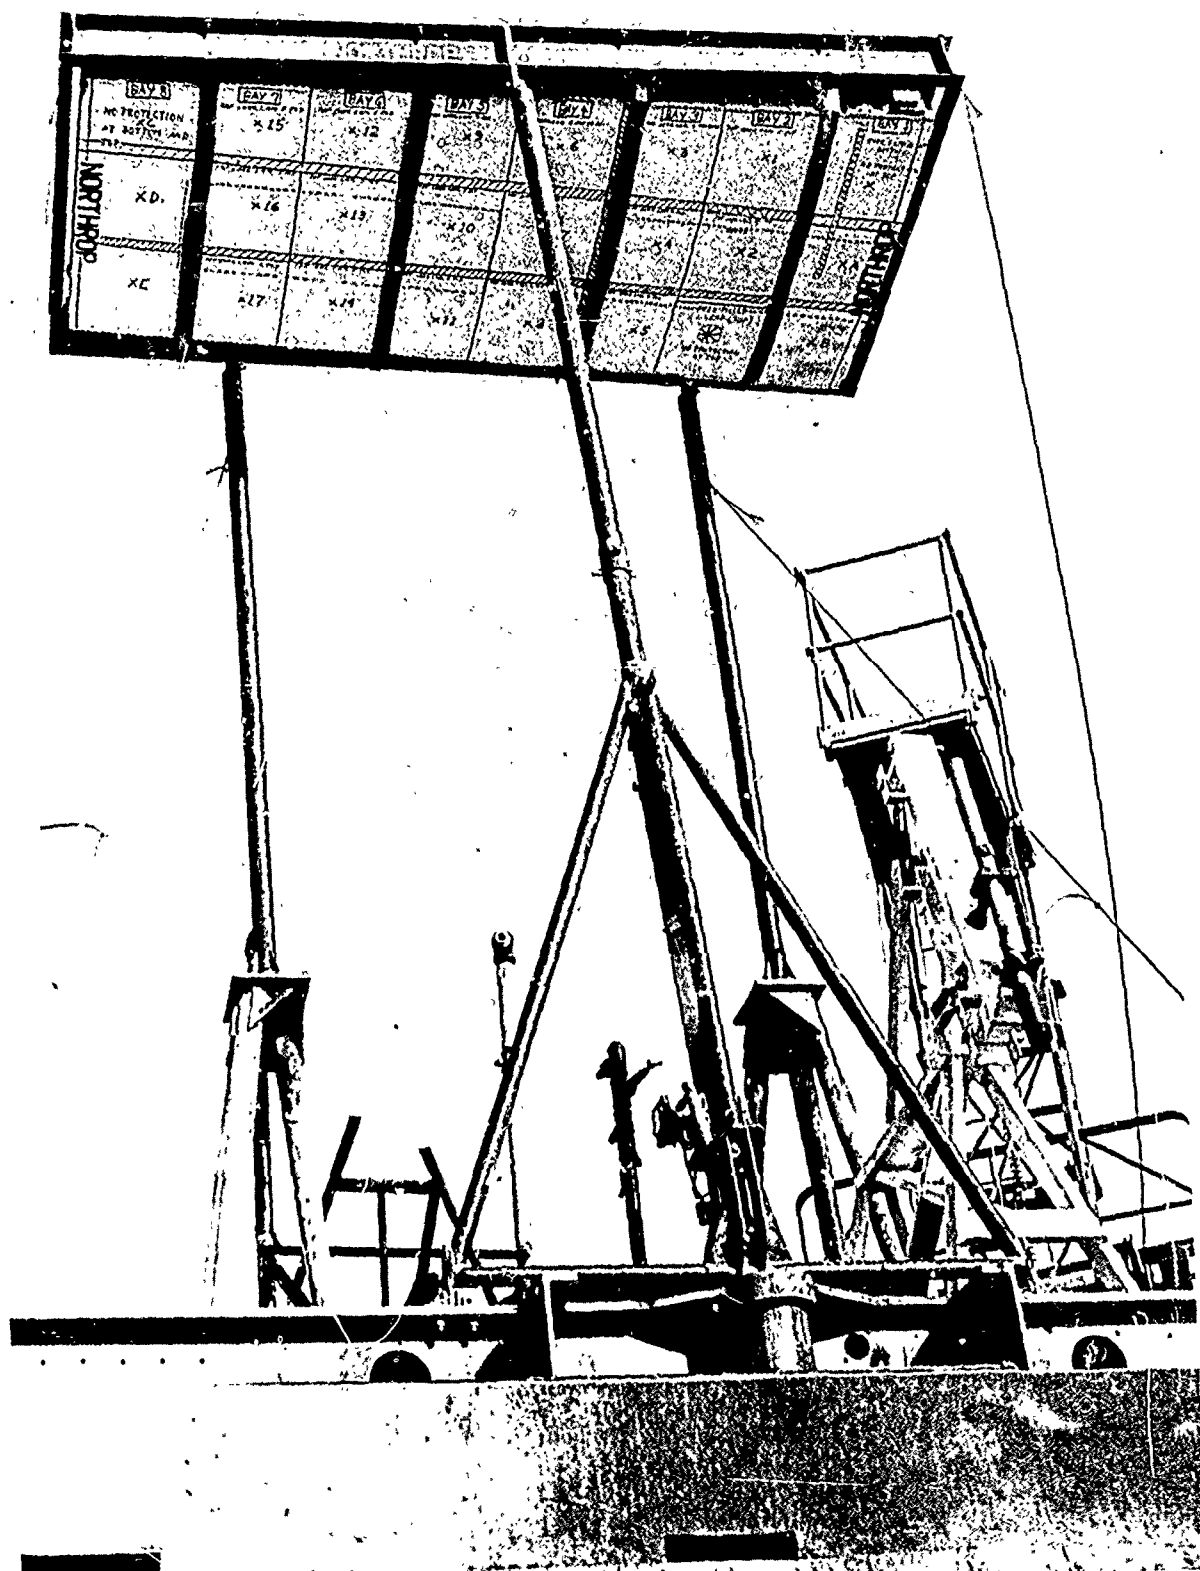
FIGURE 44. FIRING TEST TANK MOUNTED ON THE TEST STAND

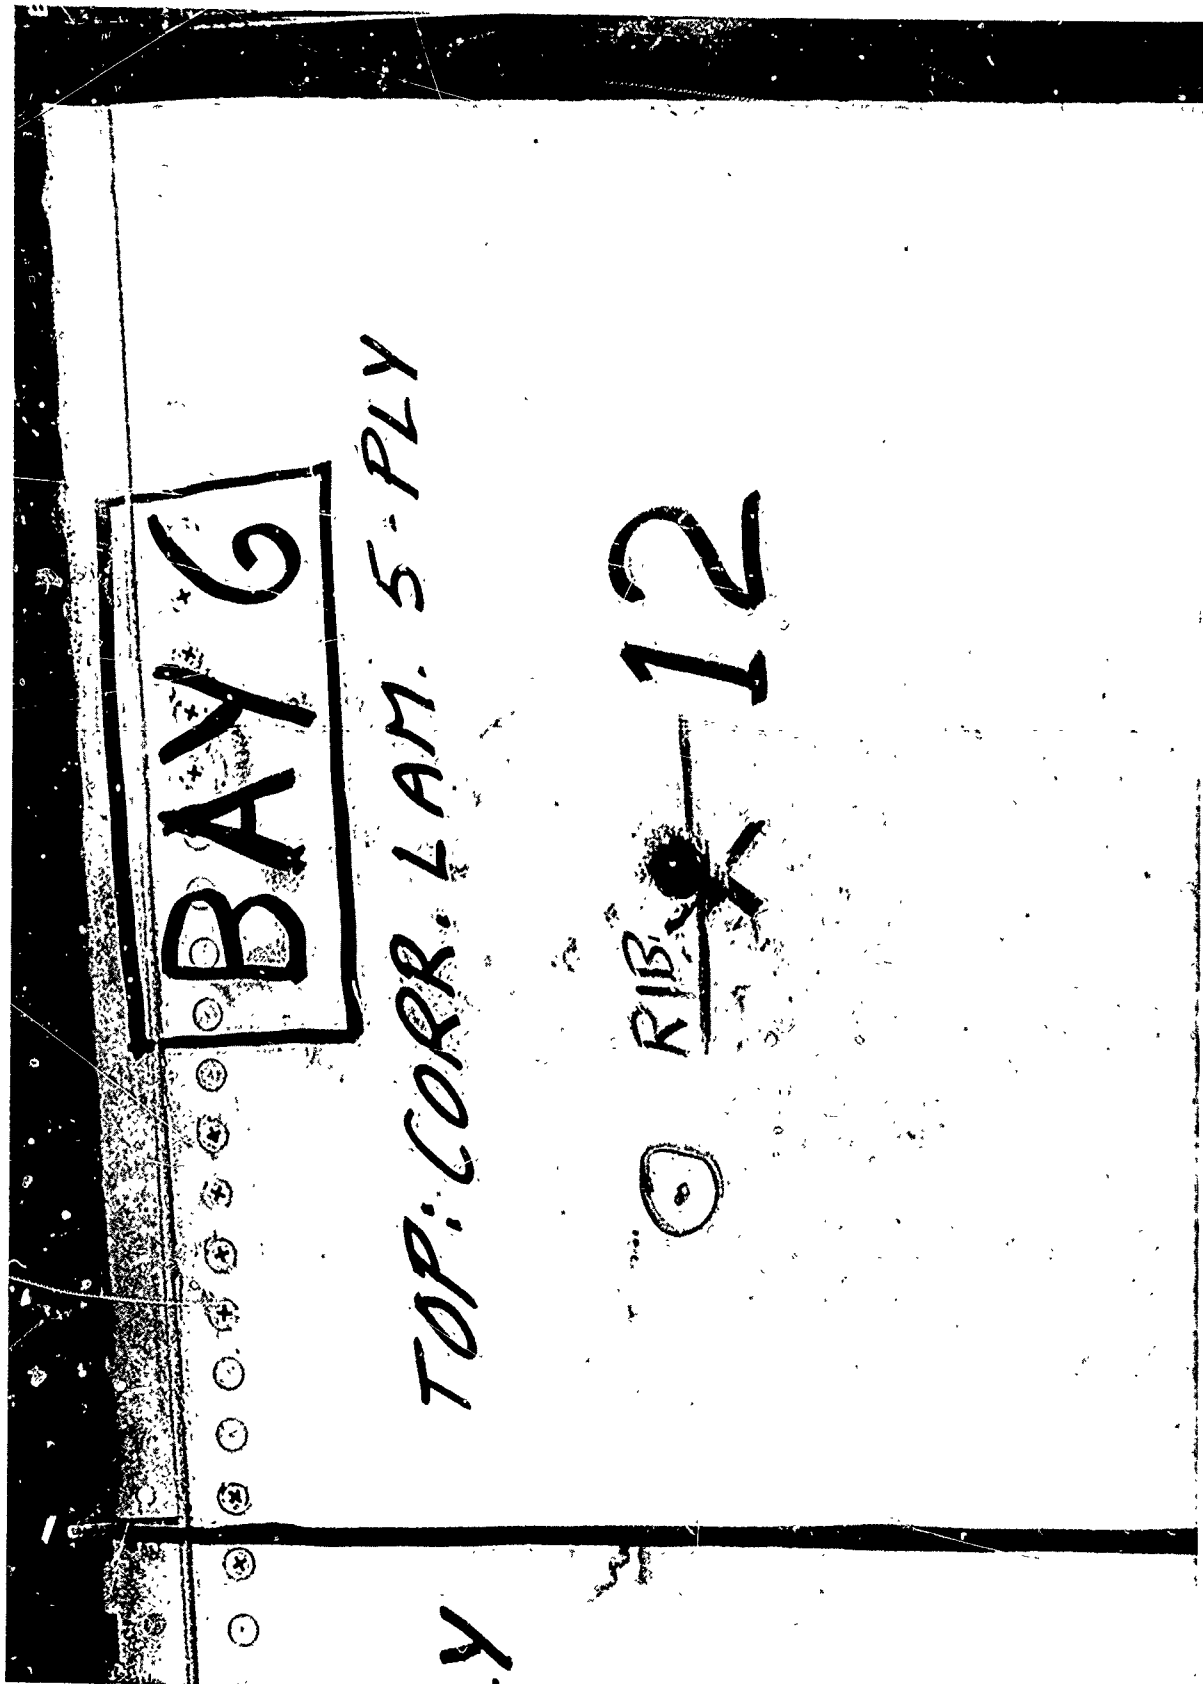
FIGURE 45. TEST NO. 1, .50 CALIBER AP VERTICAL - ENTRY FACE OF THE TANK

The projectile hit straight on, not tumbled, at the entry. On its way in, it hit a rib. The damage provoked at the entry was a 1/2-inch diameter circular hole. The precompressed foam partially sealed the hole as shown in Figure 45. The plain laminate bonded to the precompressed foam behind the entry wall of the tank showed a tiny hole as illustrated in Figure 46. The initial leakage through the entry hole was approximately 60 cc/min., which dropped two hours later to almost 0 cc. The leakage was measured by means of a long plastic pipe, which was adapted at one end against the punctured hole. The leaking fuel was then collected in a graduated cylinder and measured.

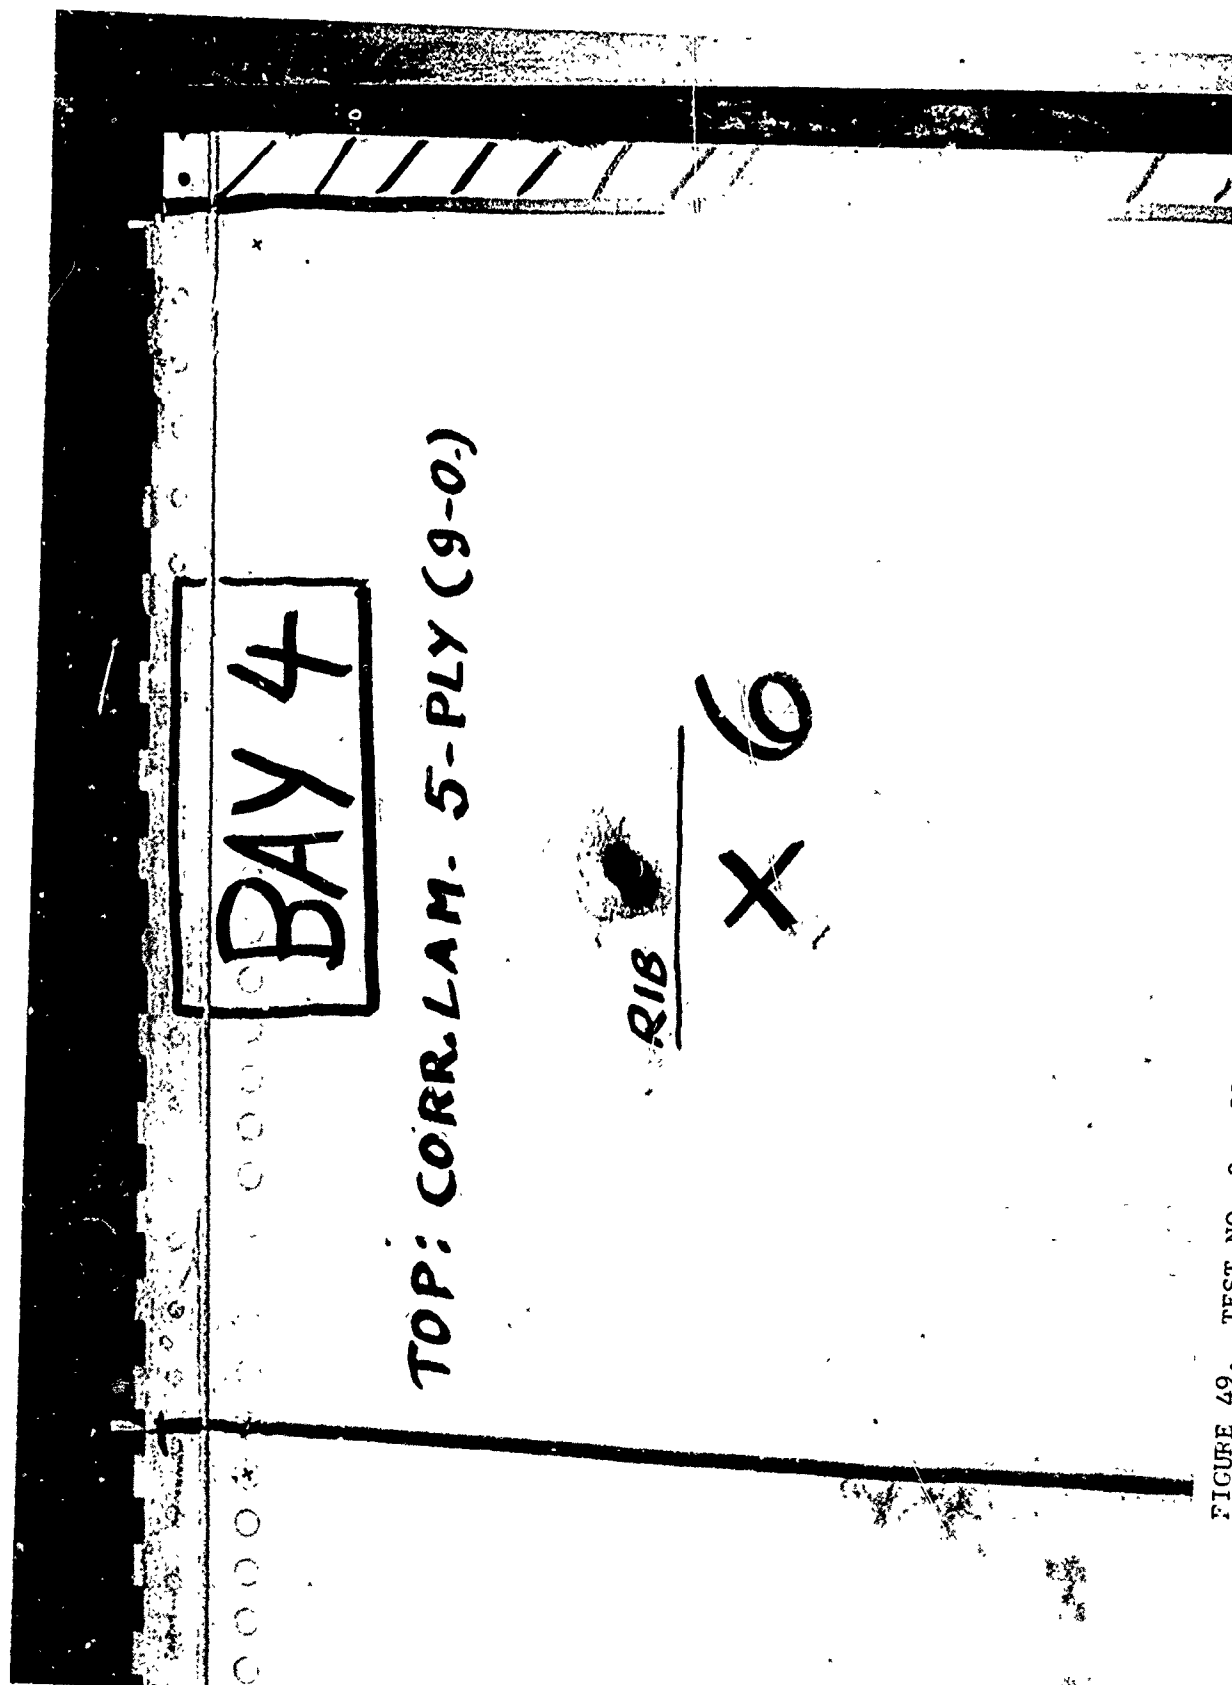
FIGURE 49. TEST NO. 2, .50 CALIBER AP, 45° FROM VERTICAL - ENTRY FACE OF THE TANK

In this shot, the projectile penetrated the tank entry wall in a 45° angle of incidence and hit a rib. The rib ruptured but the precompressed foam, the corrugated laminate, and the plain laminate, kept the damage low. The damage at the entry was a 1/2-inch diameter hole slightly deformed due to the 45° angle impact, as seen in Figure 49. The plain laminate showed a small hole as illustrated in Figure 50. The heavy damage seen on this last picture was due to shot No. 8 (20 mm.), and not to shot No. 2. Measurement of the leakage using the plastic pipe indicated a rate of approximately 30 cc./min. After awhile, this small leakage had appeared to have dropped considerably below this figure.

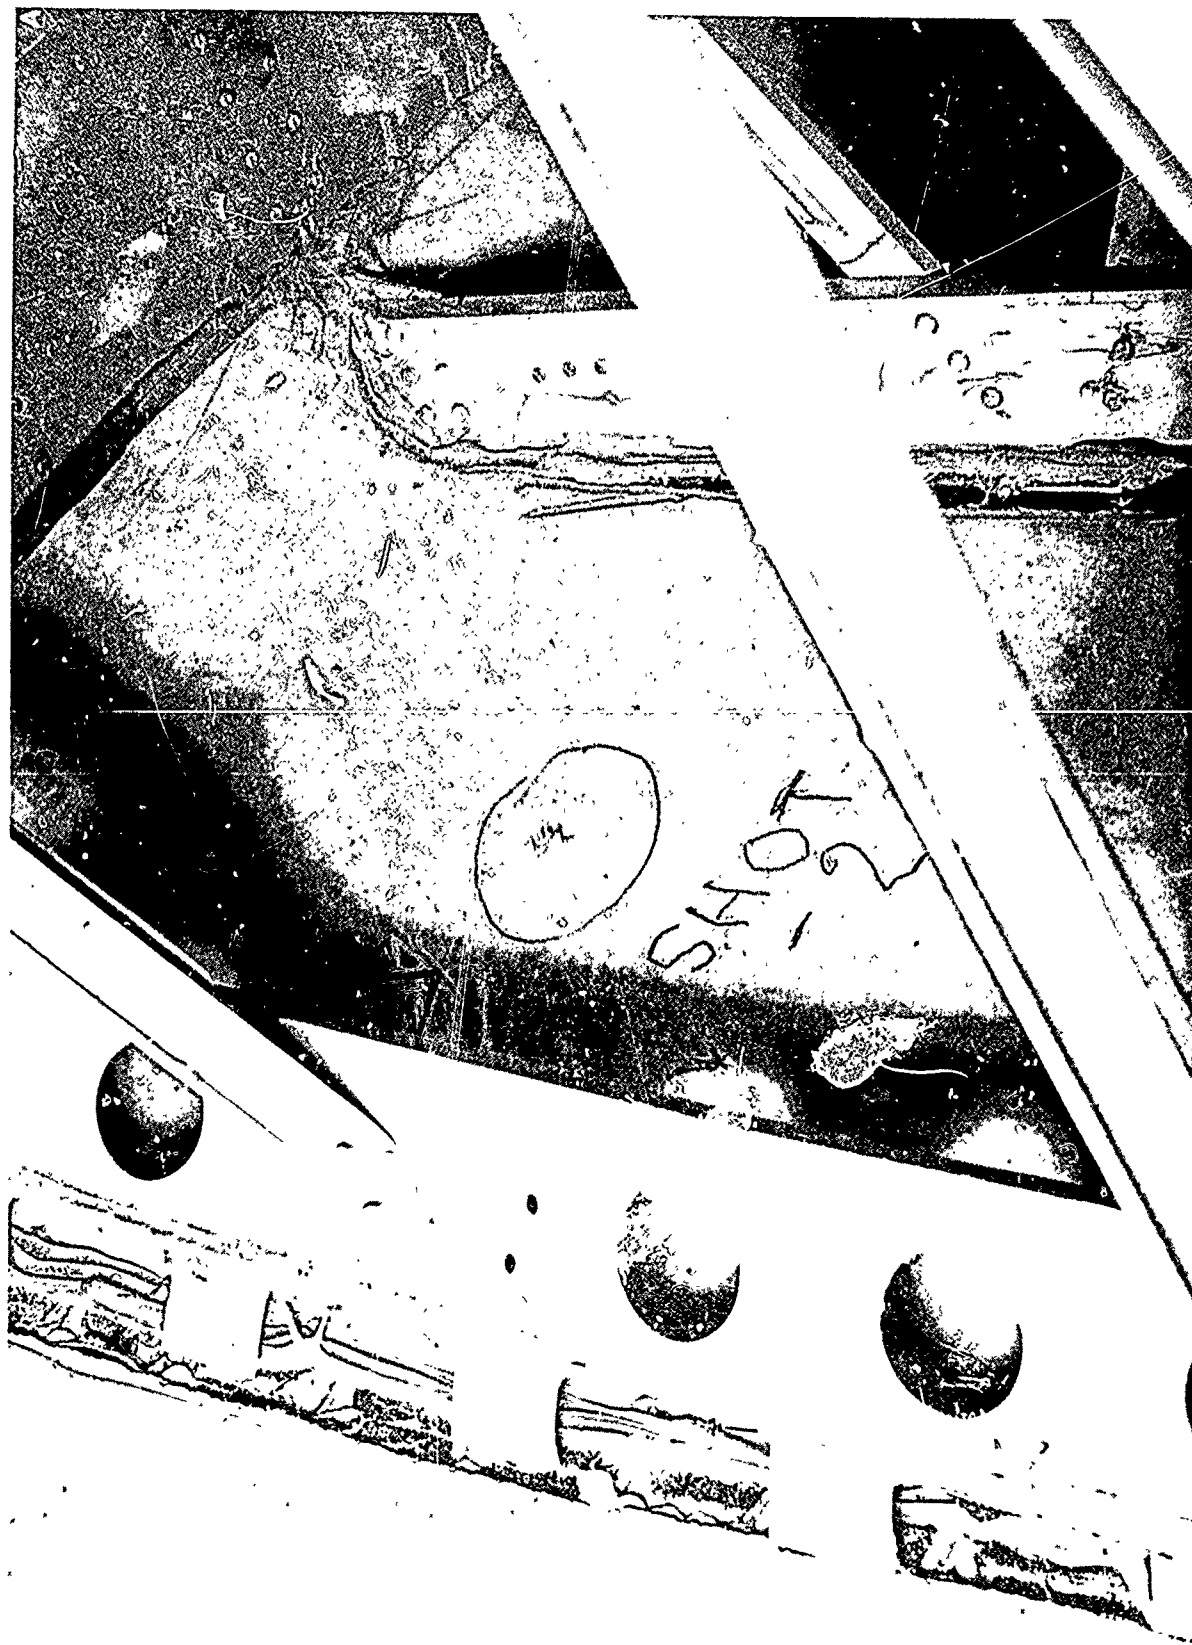
FIGURE 50. TEST NO. 2, .50 CALIBER AP 45° FROM VERTICAL - PLAIN LAMINATE
BEHIND THE ENTRY WALL IS SHOWN

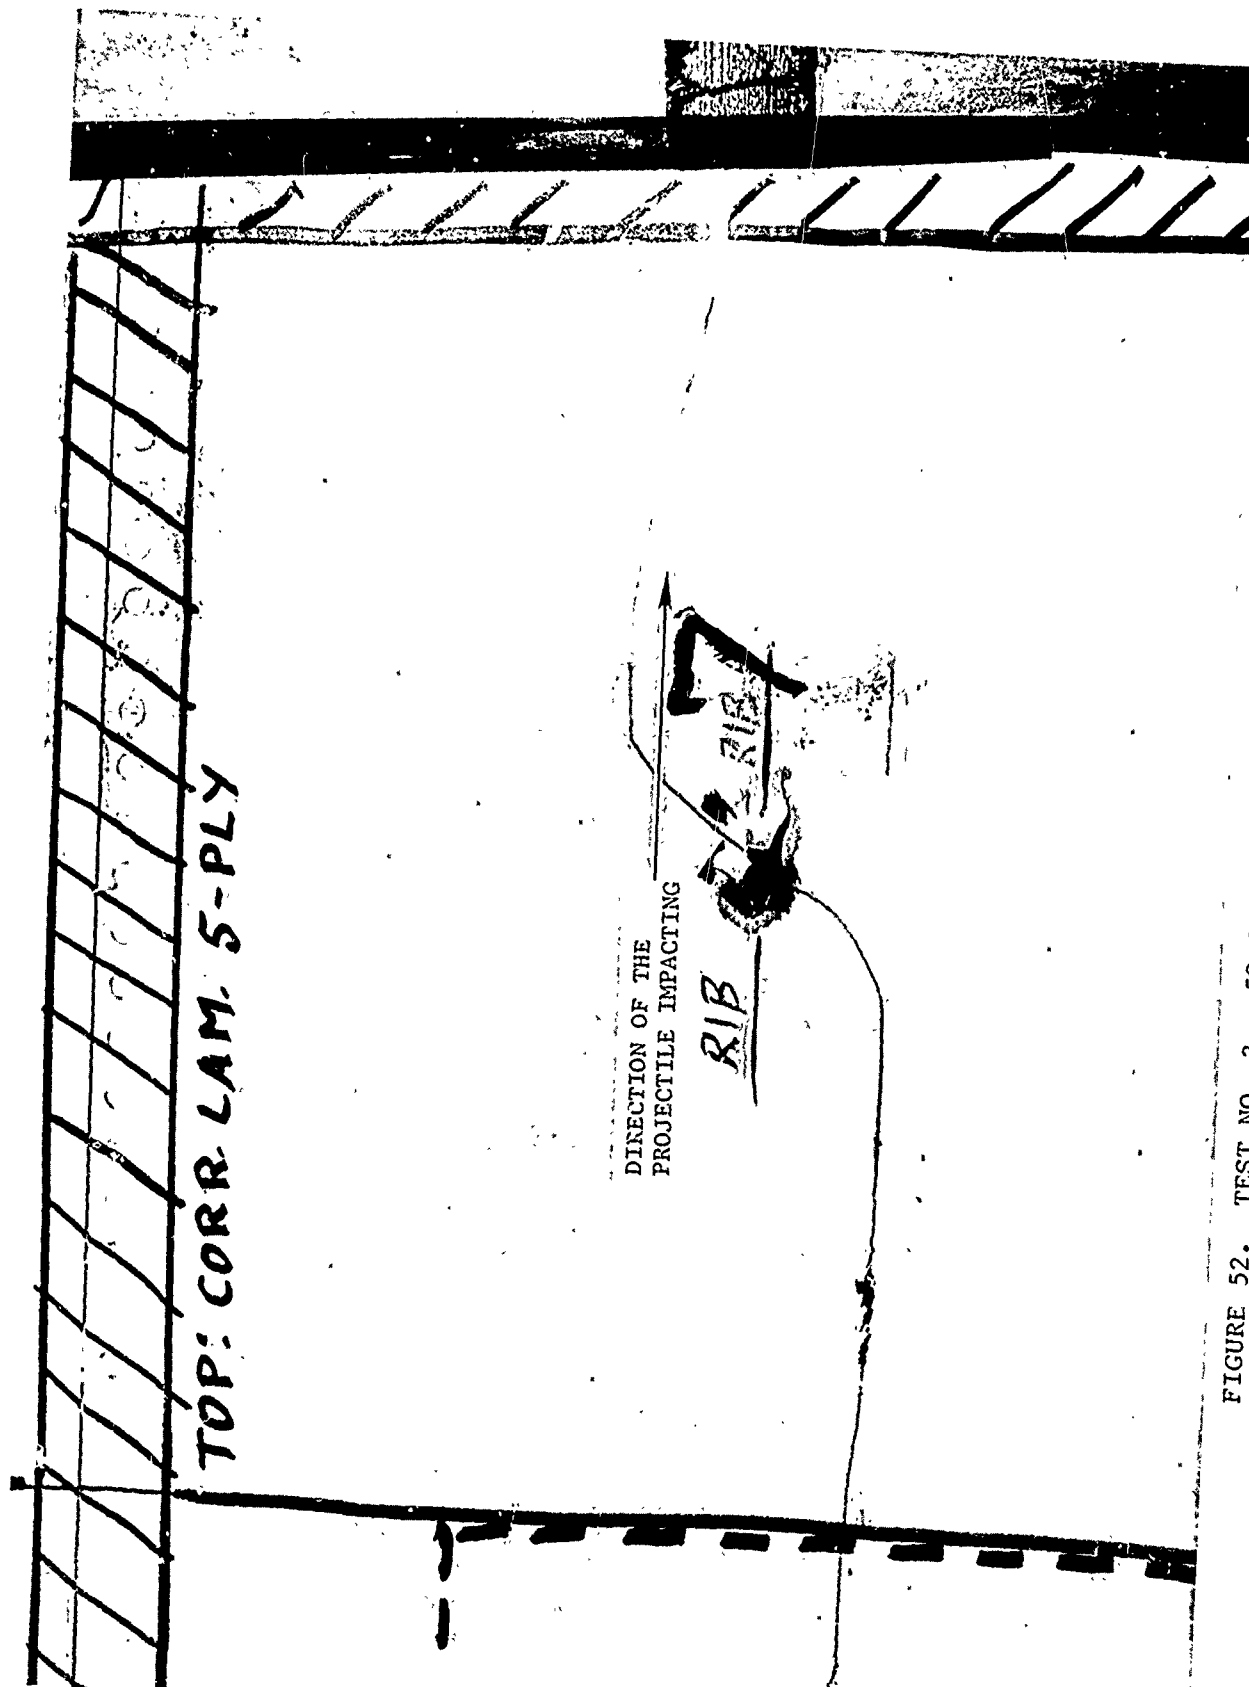
FIGURE 52. TEST NO. 3, .50 CALIBER AP, 45° FROM VERTICAL -
ENTRY FACE OF THE TANK

The projectile penetrated in a 45° angle of incidence and hit a rib longitudinally as shown in Figure 52. The projectile tumbled immediately behind the entry metal skin and exited the plain laminate or the entry skin in a fully tumbled condition. This was ripped as is shown in Figure 53. This sudden tumbling of the projectile right behind the entry wall and the rupturing of the rib dumped a tremendous amount of energy at this spot and produced a high pressure ram wave. This provoked a long crack (approximately 39 inches) and some petalling at the metal skin entry wall, as is shown in Figure 52. The leakage recorded was 3.2 liters/min. After the entry, the tumbling projectile proceeded through the tank. Before it was stopped inside the tank, it fractured two vertical trusses (OWS 334 and OWS 317) and hit part of the cover. The hit cover and one of the hit trusses are shown in Figure 54. The projectile was recovered in the reticulated foam next to that fractured truss. On the sketch in Figure 48, the points of impact of the projectile and its trajectory through the tank are shown. Coverage with the high-speed motion picture cameras was obtained of this shot.
